United States Department of the Interior
National Park ServiceNational Register of Historic Places
Registration Form

historic name Elkridge Furnace Complex

HO-367

street & number 5730 & 5741-5745 Furnace Ave., 5735 Race Road N/A not for publicationcity, town Elkridge

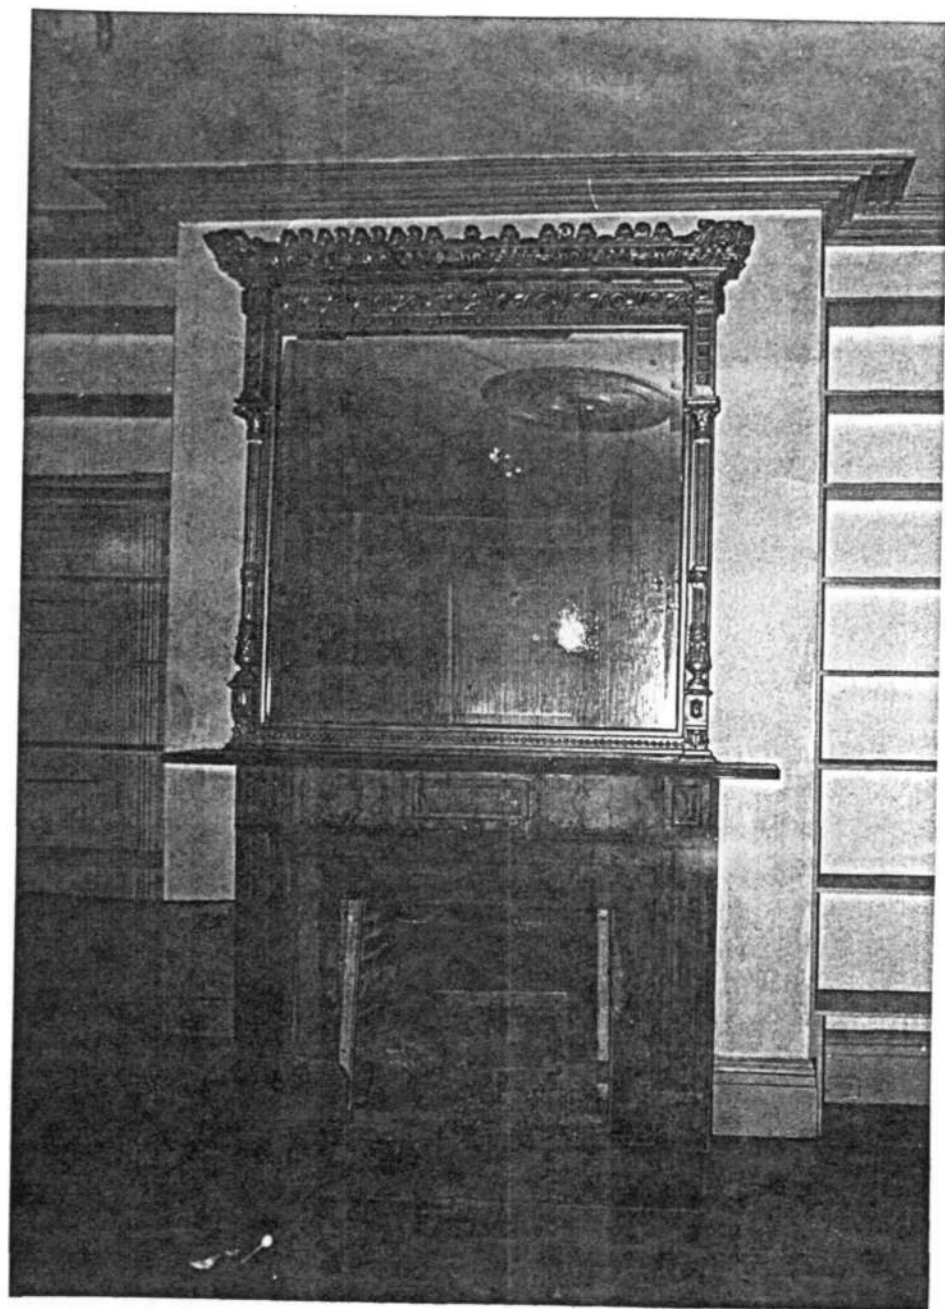
ELKRIDGE FURNACE COMPLEX NO-367
HOWARD CO., MD
PETER KURTZE 3/88
NEG AT MD SHPO
TYPICAL WINDOW TRIM, BASEBOARD, &
CORNICE, S. PARLOR
8/19

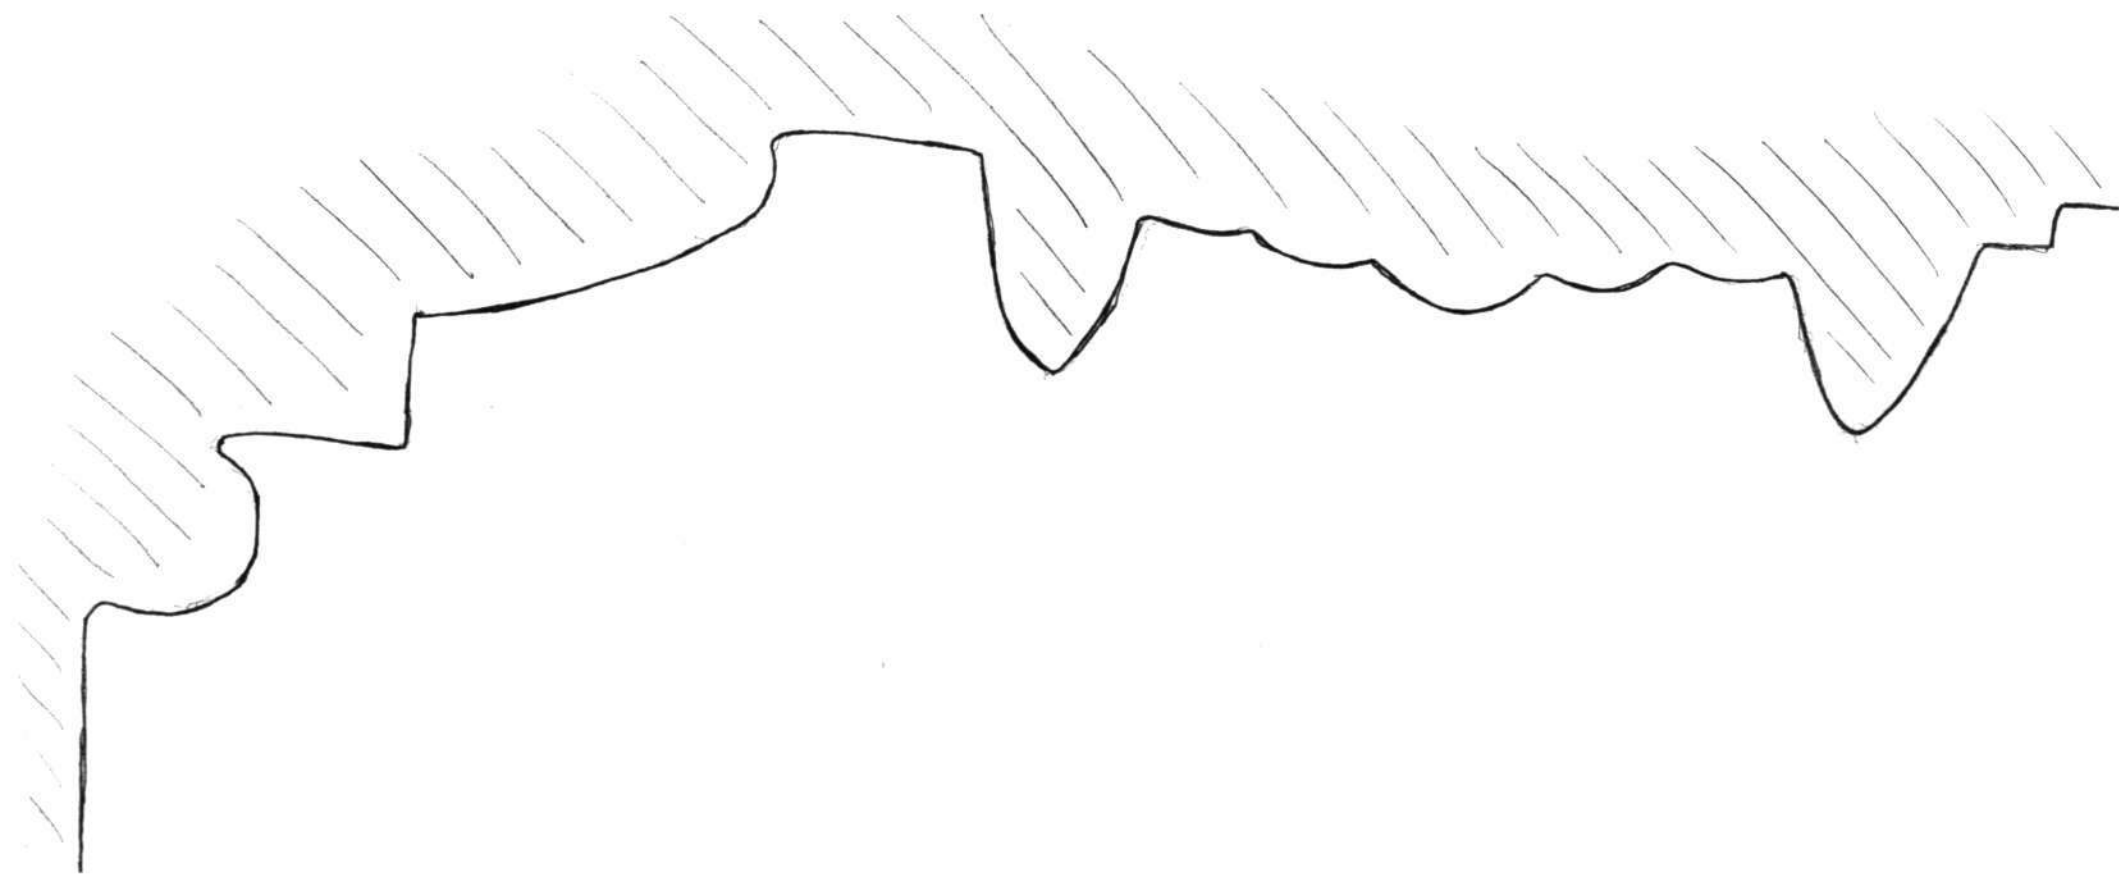
Elkridge Furnace Complex - Brick House
Ceiling Medallion Profiles

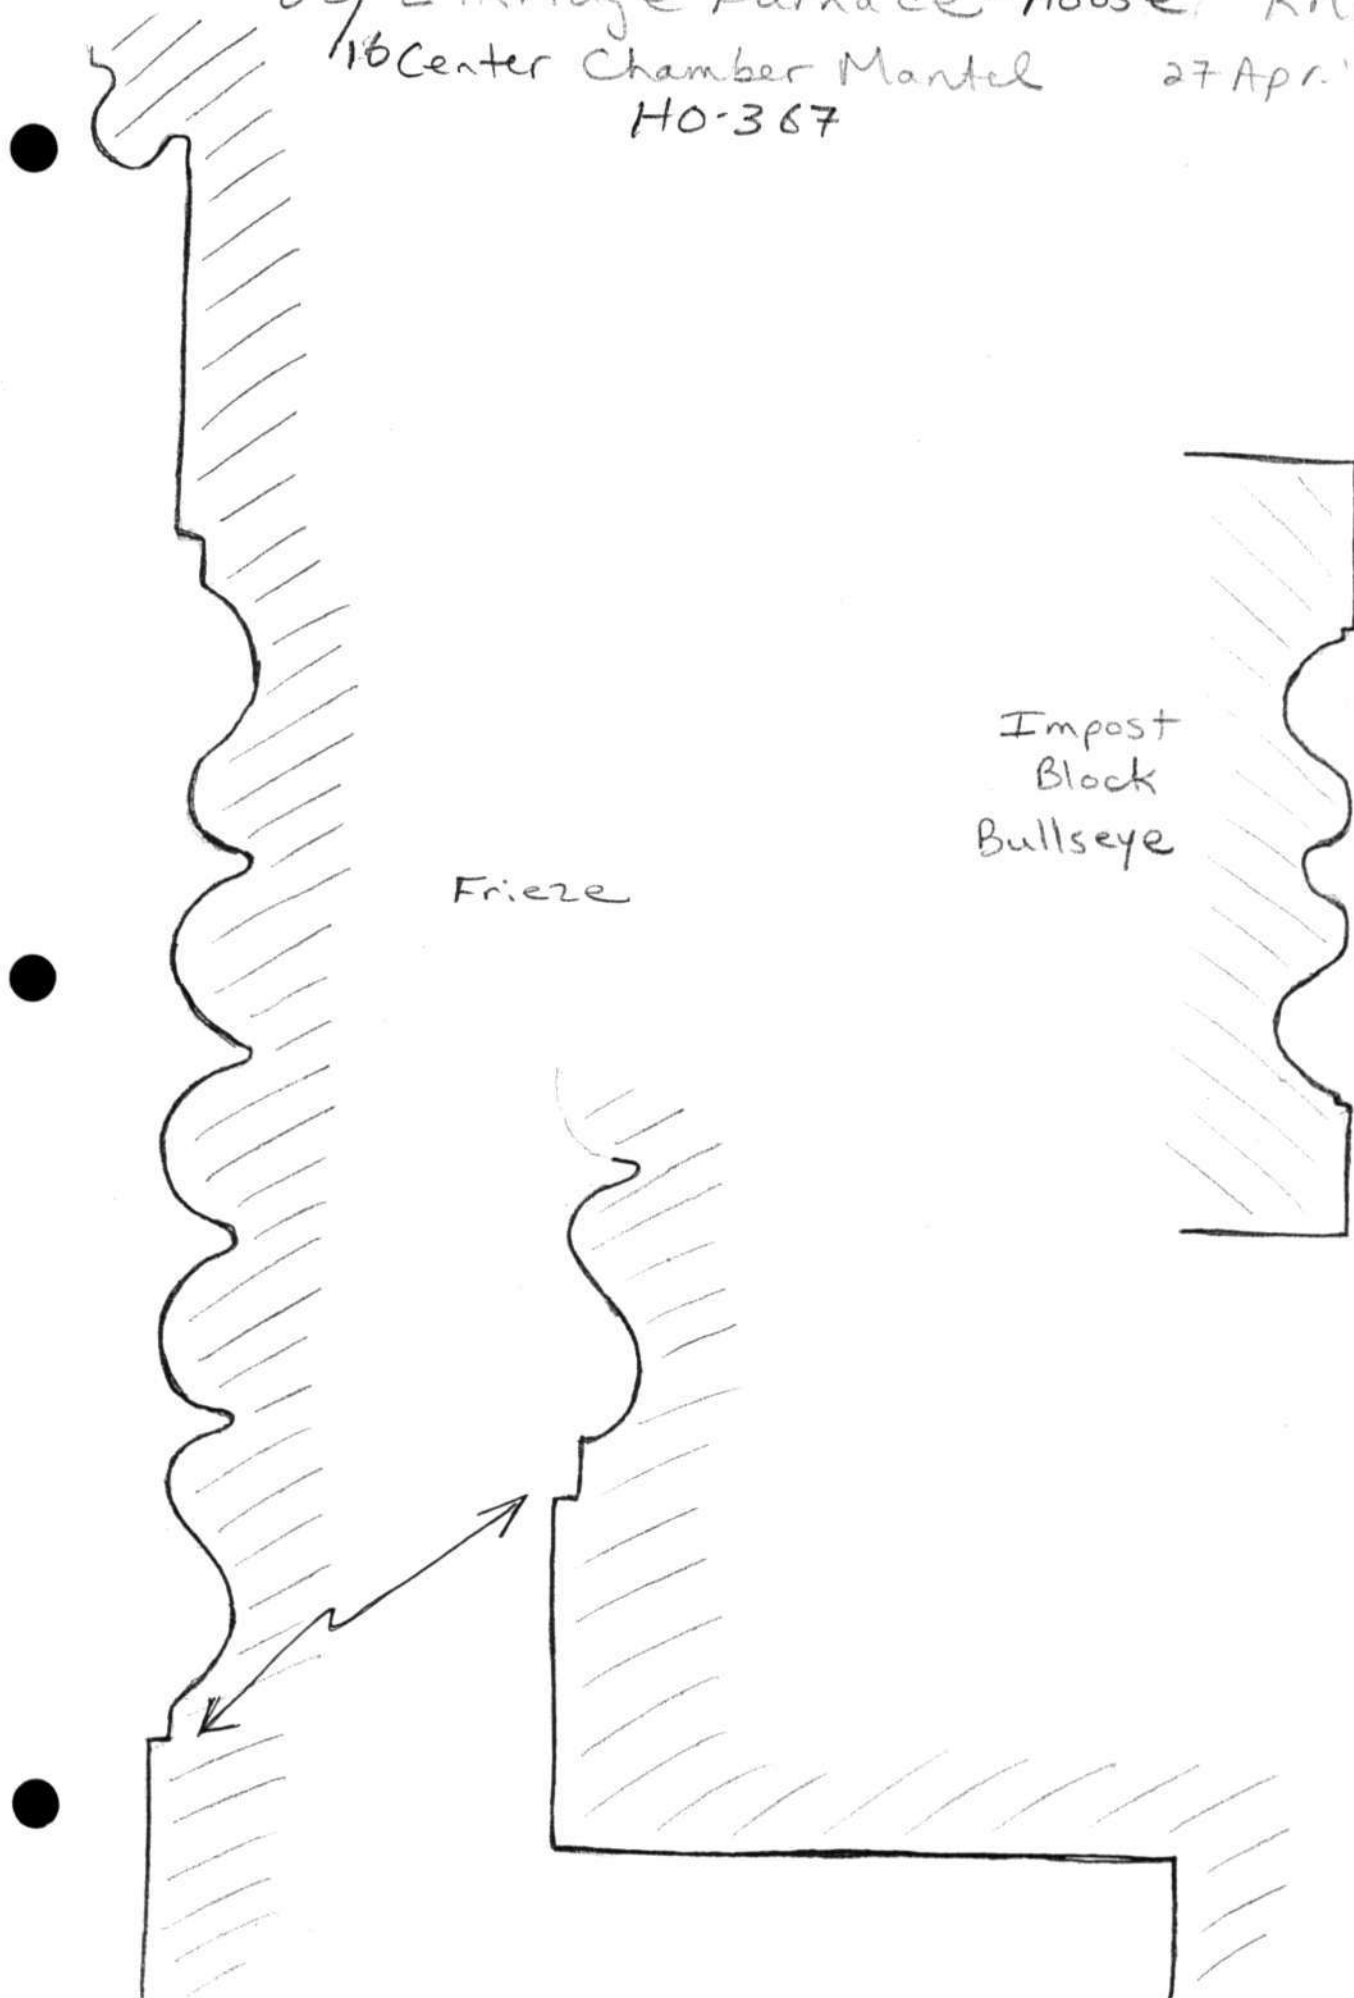
8C/16 Elkridge Furnace-
Center Chamber

House
Mantel
HO-367

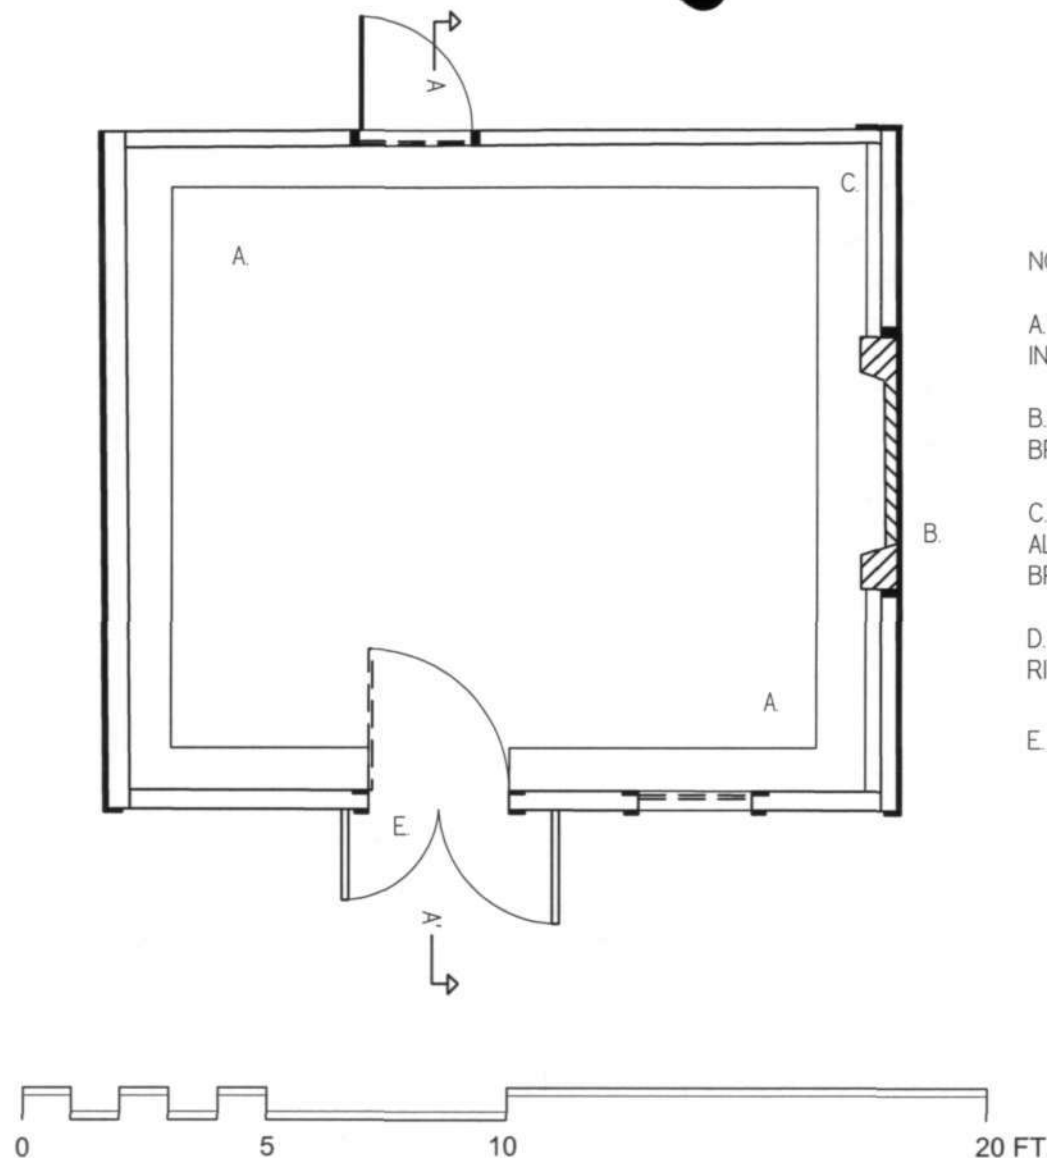
H0-367 ELKRIDGE FURNACE COMPLEX 5741-45 FURNACE AVENUE, ELKRIDGE

SOUTHEAST LOG OUTBUILDING -- TRANSVERSE SECTION -- MEASURED BY KEN SHORT & BRUCE ALEXANDER -- DRAWN BY KEN SHORT -- APRIL 2009

The southeast log outbuilding is a one-story, two-bay by one-bay plank log structure that is dovetailed at the corners and is covered with some weatherboards fastened with cut nails. It has a rubble stone foundation and a gable roof with corrugated metal and a northwest-southeast ridge. The log outbuilding faces southwest toward the road, and is 19 feet, 4 inches from the kitchen ell. It is located 12 feet, 1 inch from the bottom of the stairway to the kitchen ell, and is 41 feet away from the northwest log

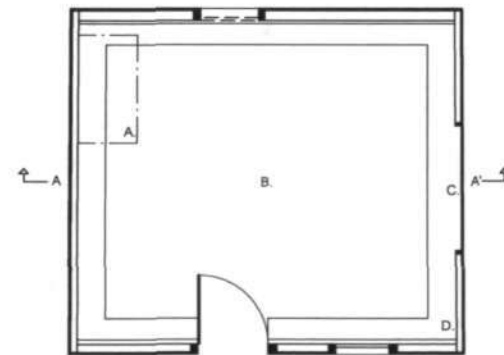
NORTHWEST LOG OUTBUILDING

NOTES:
A. REFLECTED CEILING STAIR OPENING. MODERN STAIR NOT SHOWN.
B. EARTHEN FLOOR.
C. FIREPLACE OPENING.
D. SILLS ON NORTHEAST AND SOUTHWEST WALLS ONLY. FOUNDATIONS EXPOSED ON ALL FOUR WALLS.

PLAN

The northwest log outbuilding faces southwest toward Furnace Avenue and is about 75 feet northwest of the ell of the house. It is a one-story, two-bay by one-bay log structure with a rubble stone foundation, log planks with dovetailed corners and weatherboards covering most of the logs, and a gable roof of corrugated metal with a northwest-southeast ridge. The weatherboards are random-width and are fastened with cut nails. On the southwest elevation the west bay has a beaded-edge vertical-board door with a Norfolk latch and there are about four different key or latch holes. This door was hung on hinges but is now hung on interior strap hinges. There is plain architrave that has a beaded interior edge. There is no foundation wall at the doorway opening, and there never was one, as the stone foundation has hard edges at each jamb. There are also several stones set into the ground at the threshold, suggesting that the interior always had a dirt floor. The south bay has a six-over-six double-hung sash that is mortised and tenoned and pinned at the corners. The sash have ovolo muntins, 8-inch by 10-inch lights, a wood sill with a wash, and the architrave matches the door. There is a wood box cornice. The northwest elevation has no opening on the first story. The gable end has a doorway, but the door is

On the interior, the foundation projects into the room, with a sill on top on the southwest and northeast walls. There is a dirt floor, and possibly some stones set in it. The log walls are exposed and whitewashed, and the logs are hewn, some of them having pegs broken off flush. There are also several mortises filled with wood blocks. There are several pegs still in these logs, one on the southwest wall, south of the door, which could be old. There are also thin boards or pieces of boards pushed between the logs as chinking, along with plaster used as chinking between the logs. The log planks are 3 to 3-1/2 inches thick. This building was converted to a stable at one point, and has a hayrack and several stalls. It is now filled with parts of various old buildings. The attic joists are both hewn and pit-sawn, are whitewashed, and run northeast-southwest. Many have several mortises cut through them. In the north corner is a rebuilt stair constructed with wire nails, and it ascends to the northeast along the northwest wall. The opening in the floor above the stair appears to be original, with a header at the southwest end of the opening and one joist cut out for the opening. The southwest door hinges are tapered and have lima bean cusps. The joists are set on top of the southwest and northeast logs, with neither the joists nor the logs being notched for the other. The southeast wall has a wide opening that probably originally held a fireplace. The rafters are set on the floor over top of the joists and are mitered at the foot. The rafters are hewn and most of them are mitered and butted at the ridge, though several are half-lapped and fastened with cut nails. The rafters support board sheathing. There is no patch in the floor at the southeast end, suggesting that the fireplace and chimney were exterior.

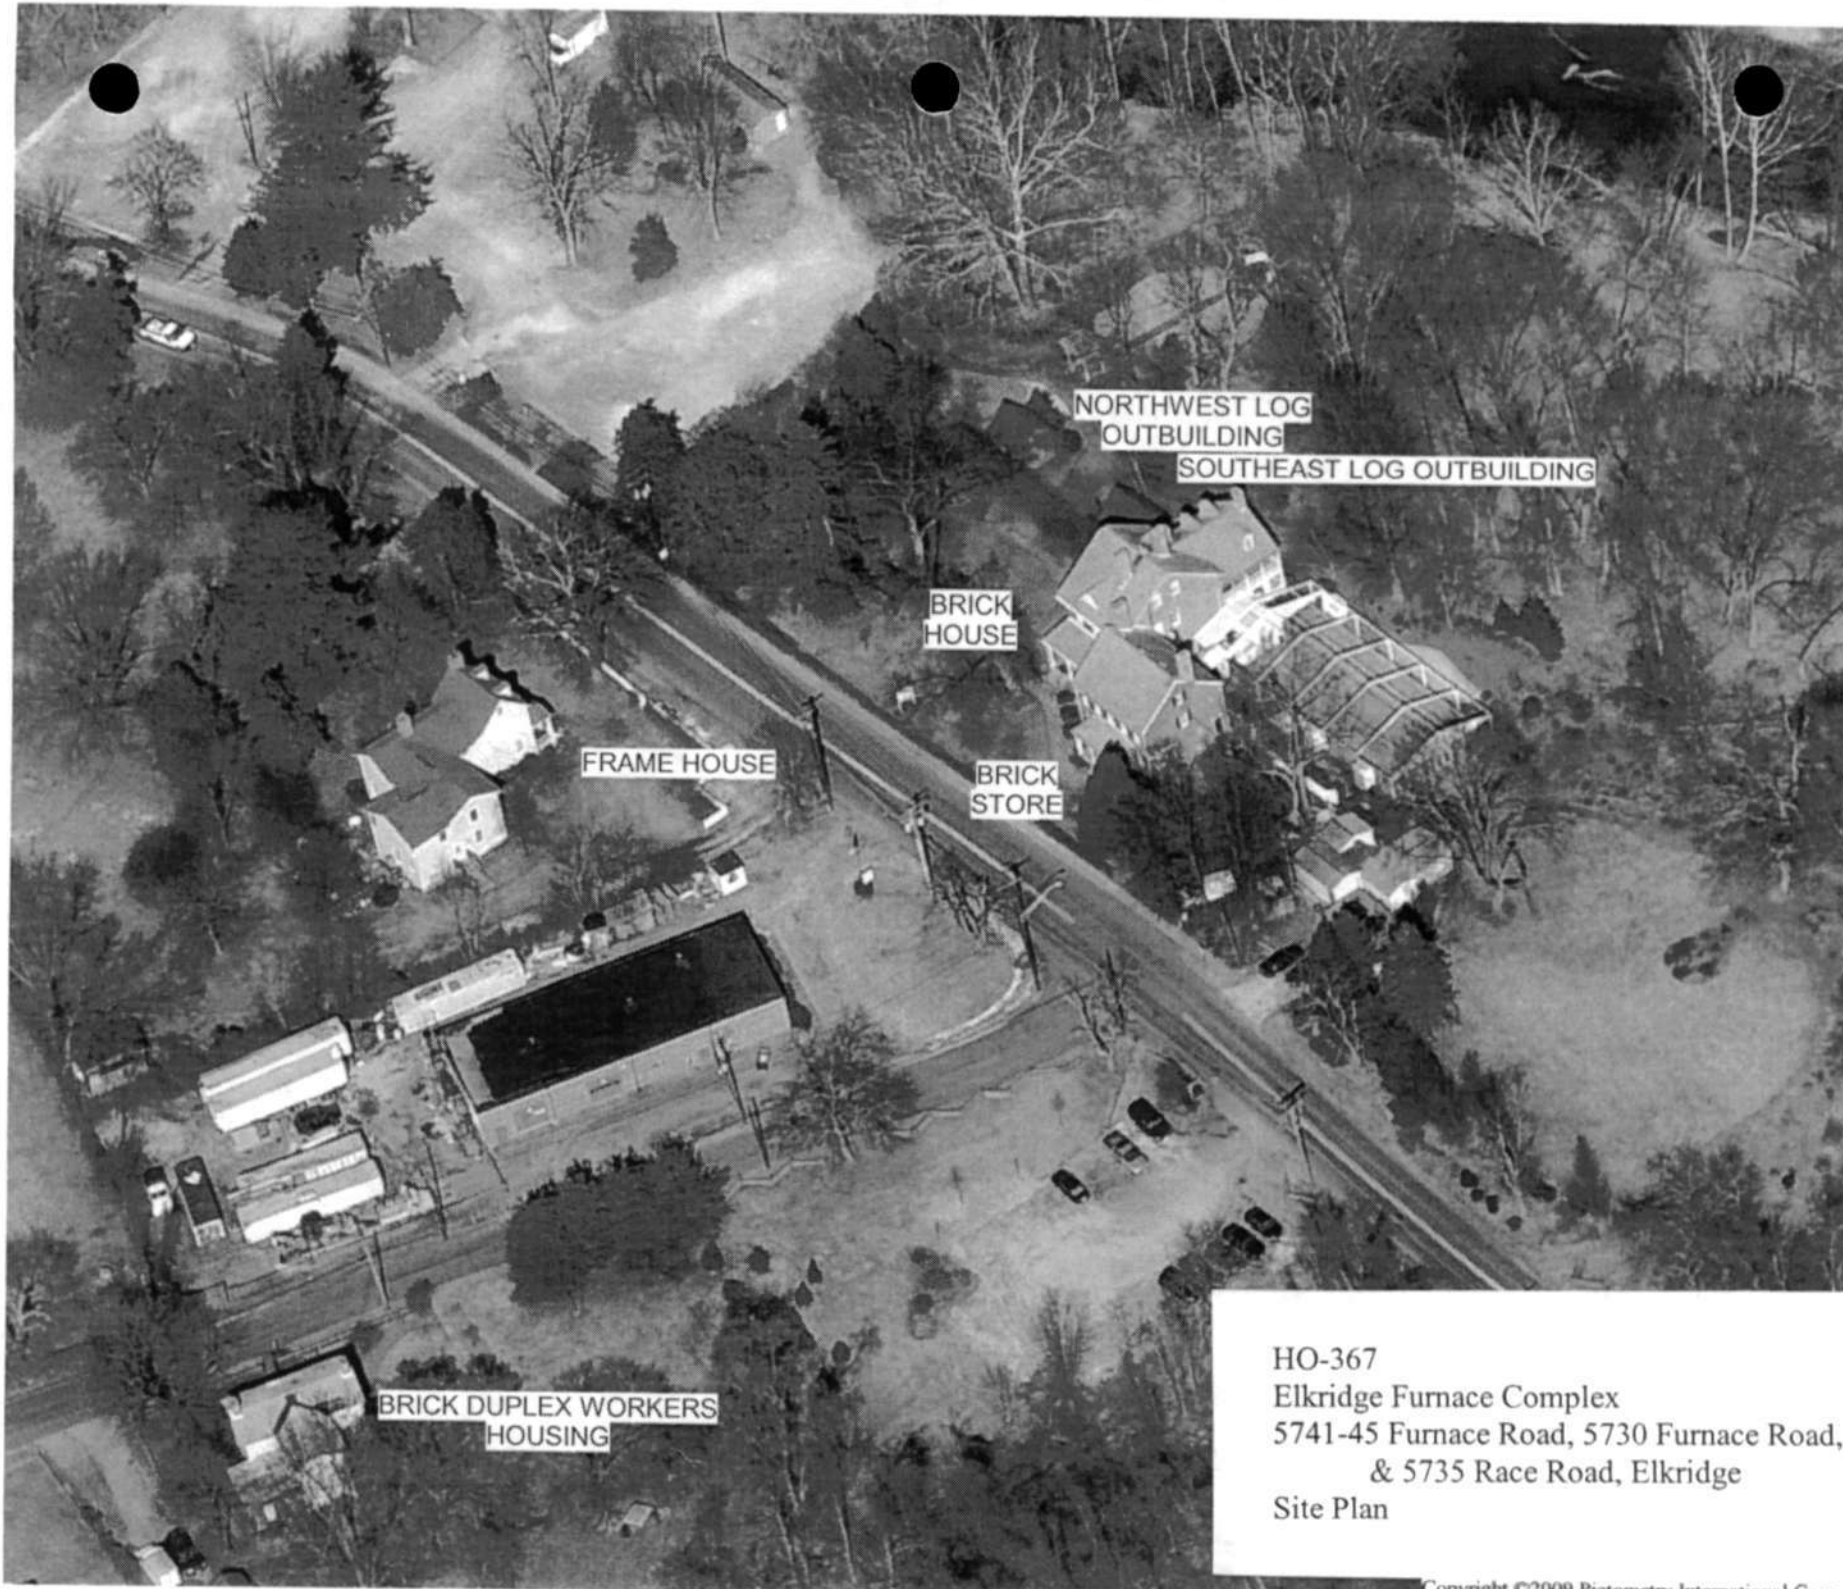
HO-367
Elkridge Furnace Complex
5741-45 Furnace Road, 5730 Furnace Road,
& 5735 Race Road, Elkridge
Site Plan

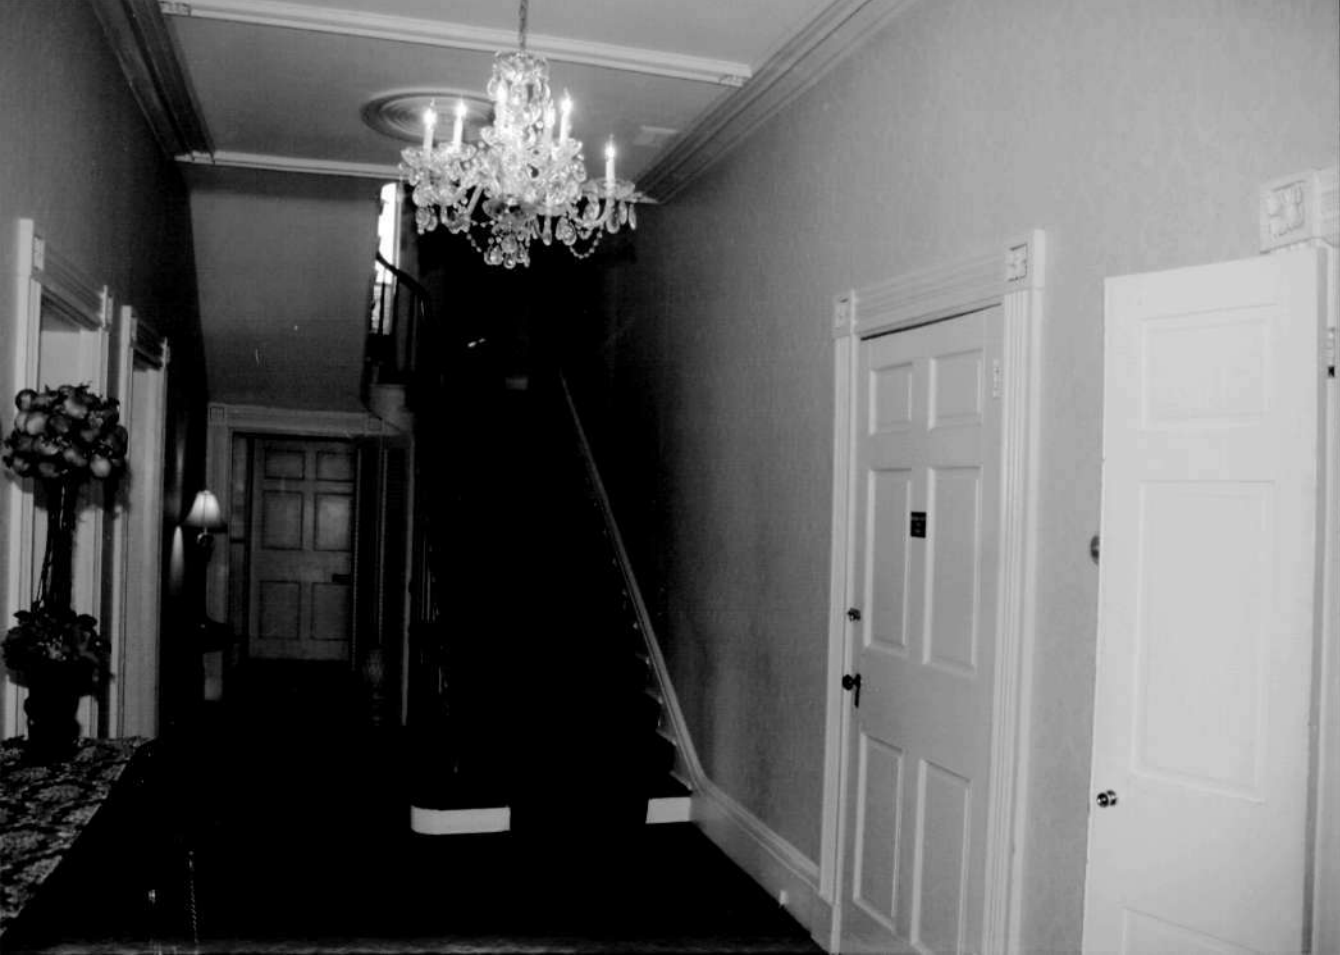
8 of ²³17

Northwest section passage,
small ceiling medallion

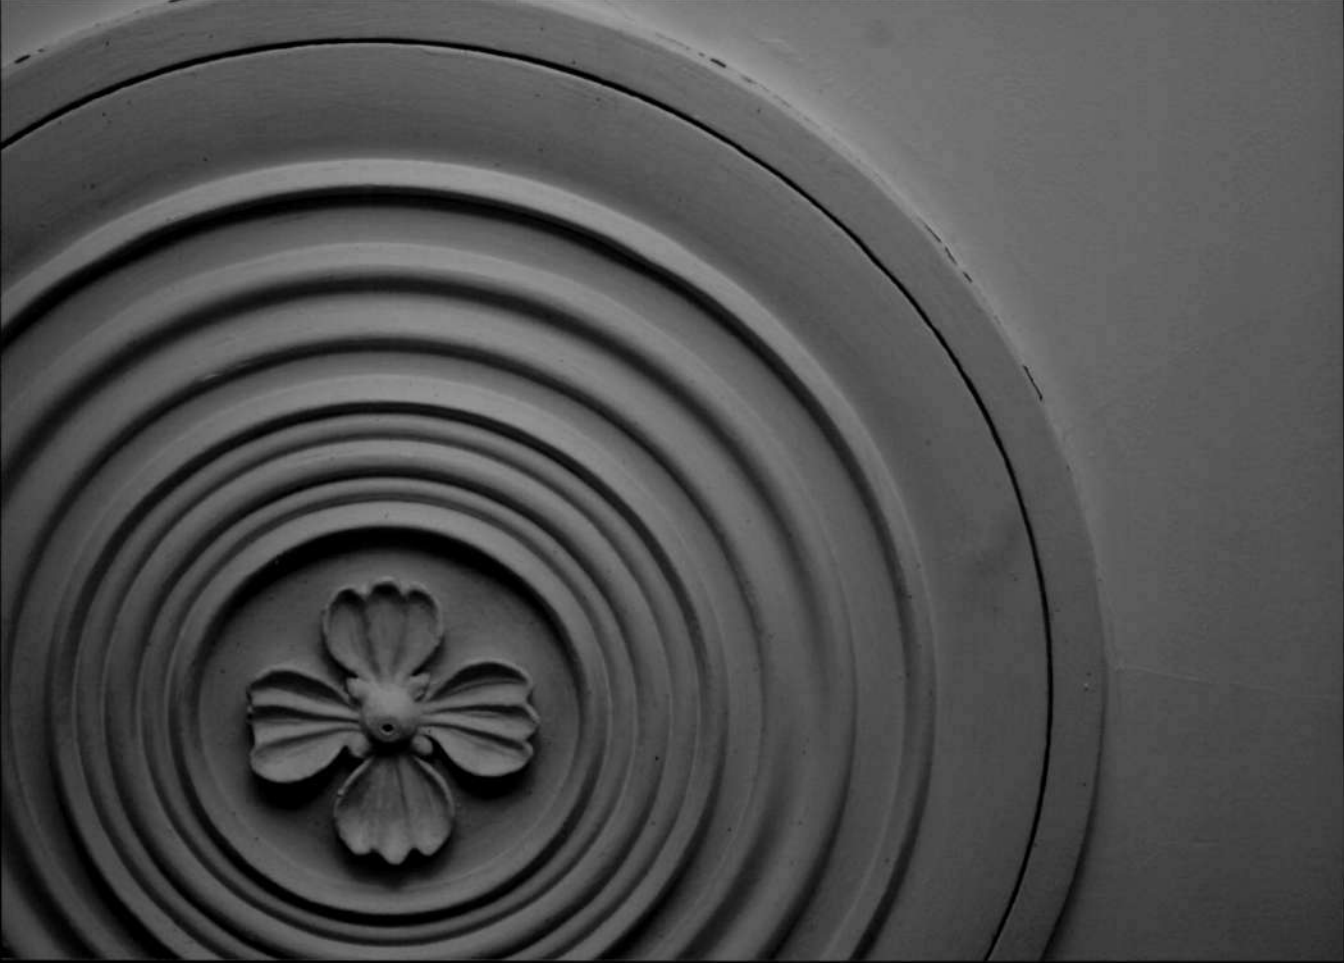
9 of ²³ 17

Northwest section passage, large
ceiling medallion

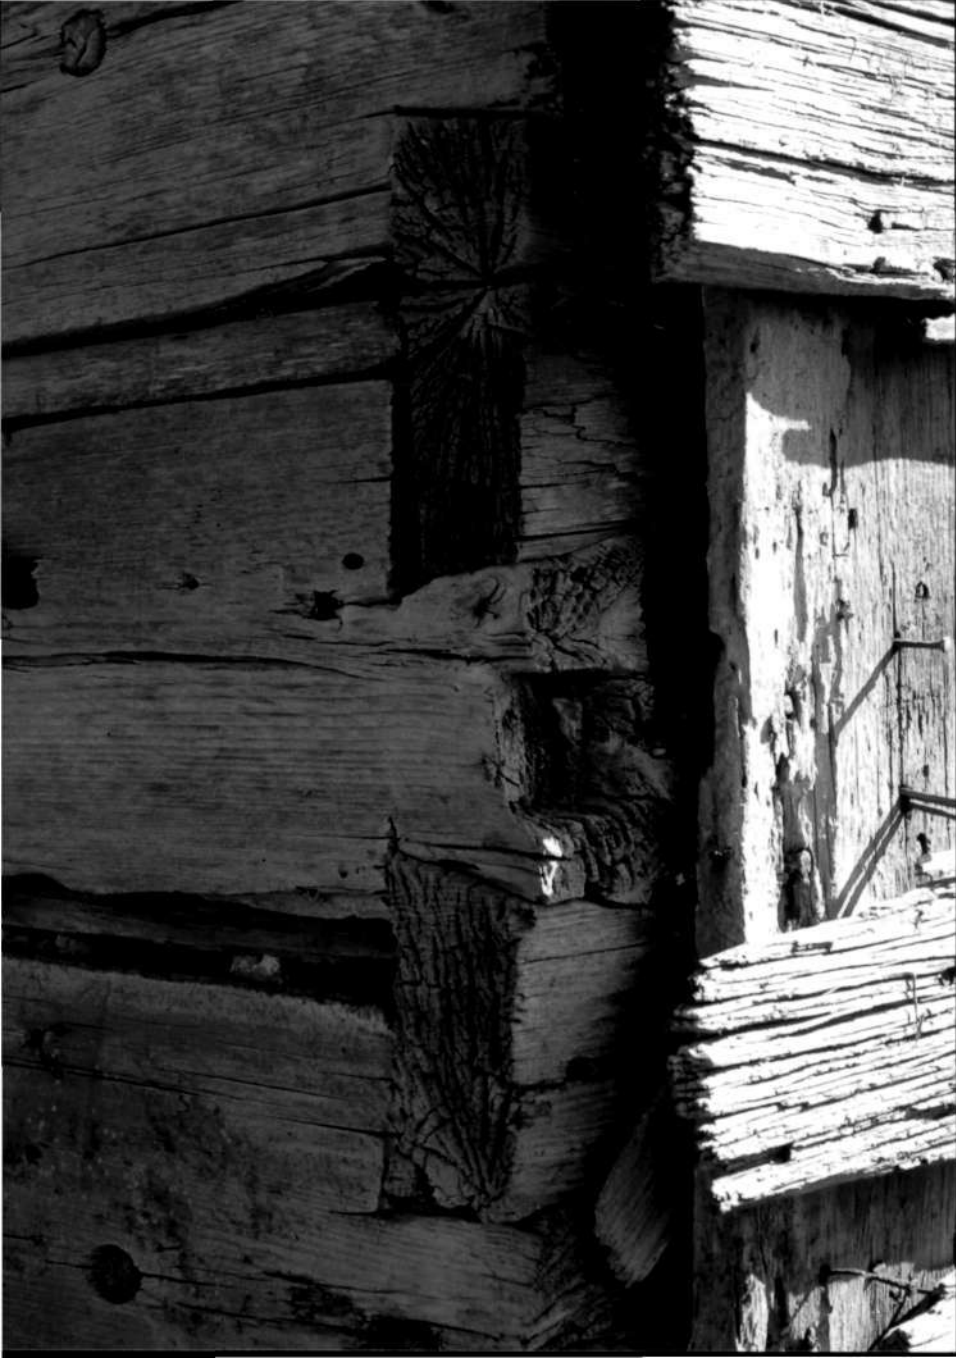
22 of 23

Southeast slave quarters, north
corner dovetails

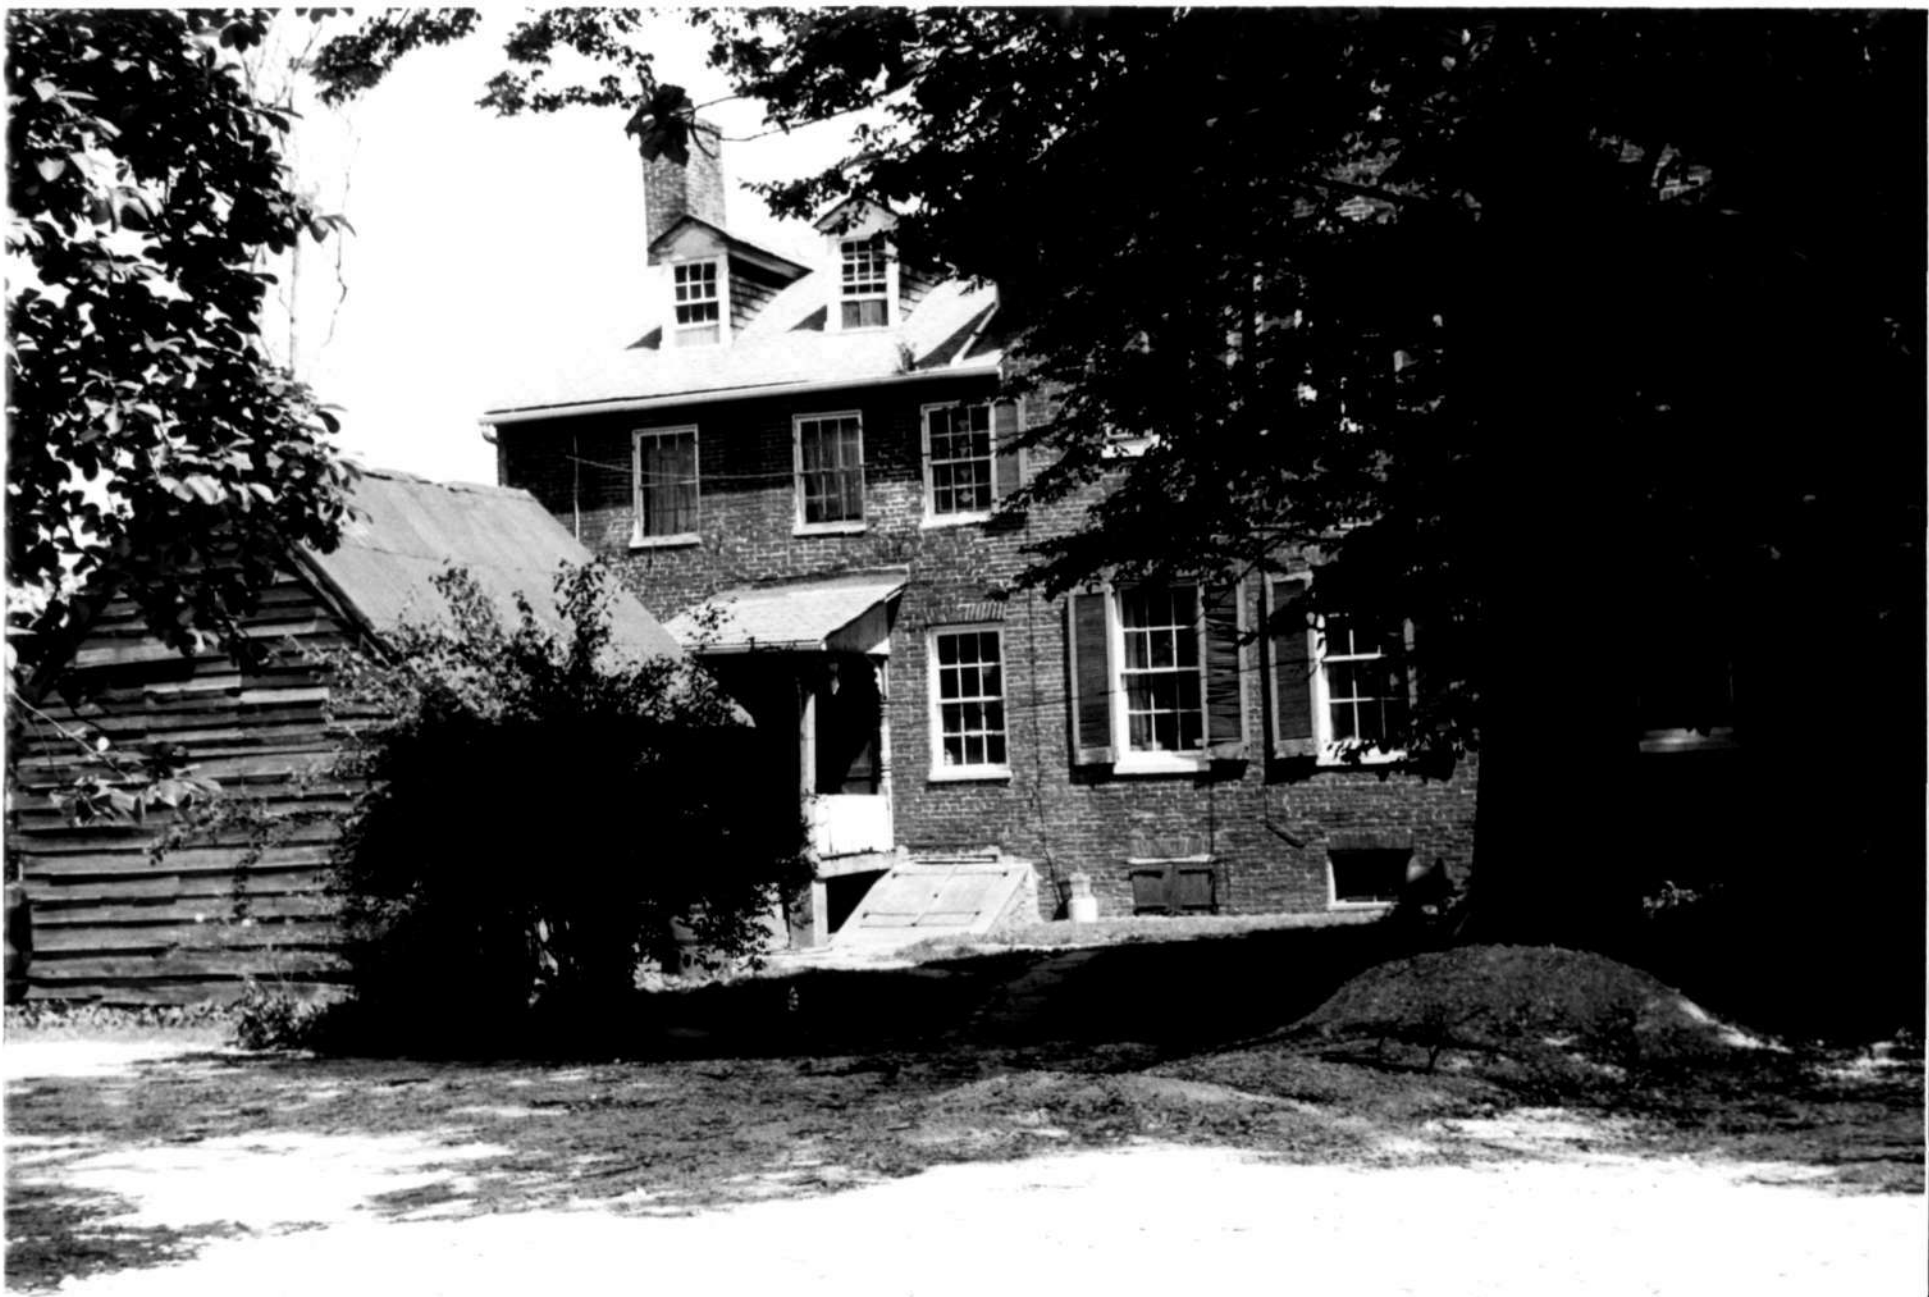
Photographer: Cleora B. Thompson, A.I.C.P.
Date of photograph: June, 1980
Negatives in possession of the Maryland Historical Trust
View: Cellar door with wooden lock under kitchen wing
Photographer looking: North
Photograph number: 7 of 10
